NOMINATION FORM
for the
NATIONAL REGISTER OF HISTORIC PLACES, NATIONAL PARKS SERVICE

1. NAME				
COMMON: Green Spring Valley Hounds Club House				
AND/OR HISTORIC: Stamford				
2. LOCATION				
STREET AND NUMBER: Southwest side of Mantua Mill Road				
CITY OR TOWN: Glynden				
STATE: Maryland		COUNTY: Baltimore

BA-171
Stamford (Philpot House, Green Spring Valley Hounds Hunt Club)
Mantua Mill Road
Hampstead Quadrangle
Baltimore County

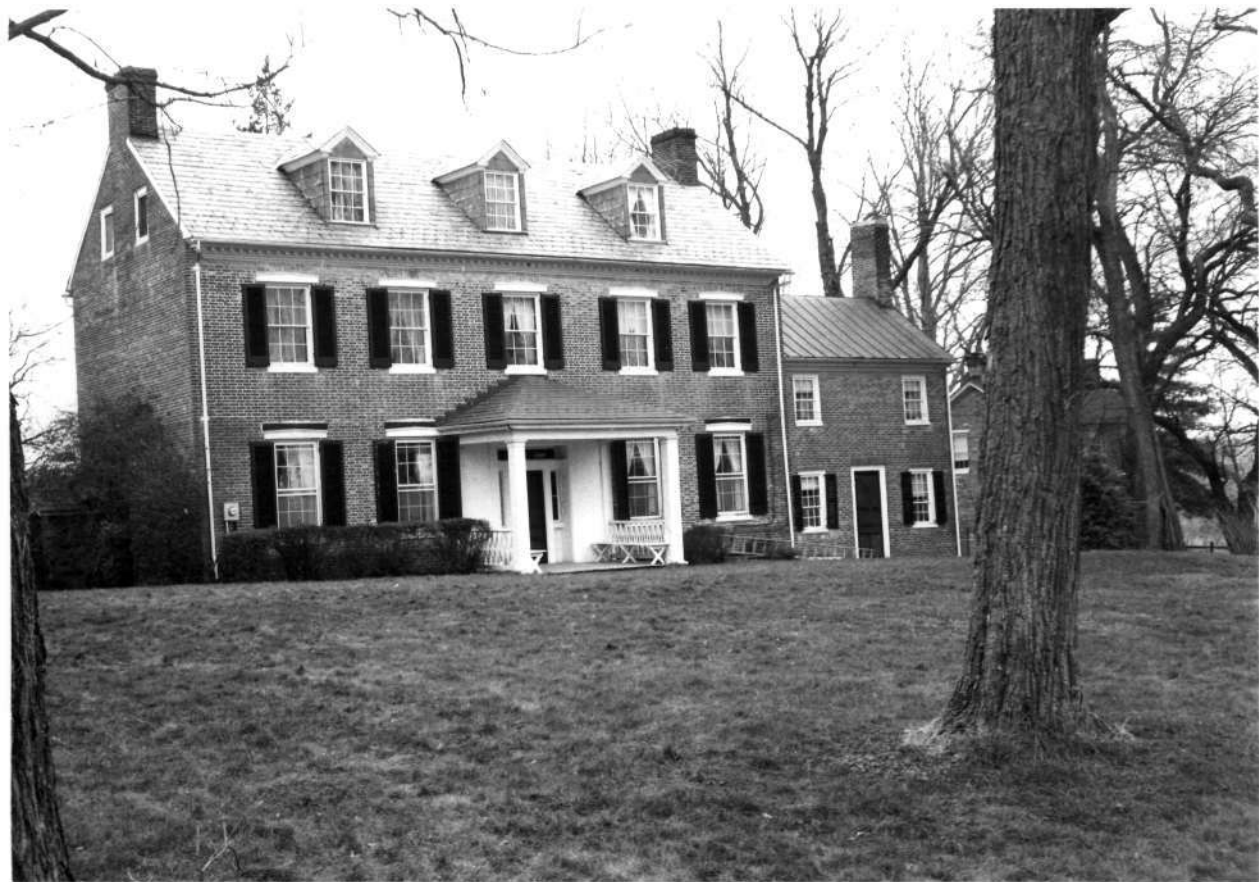
Stanford from
Southeast

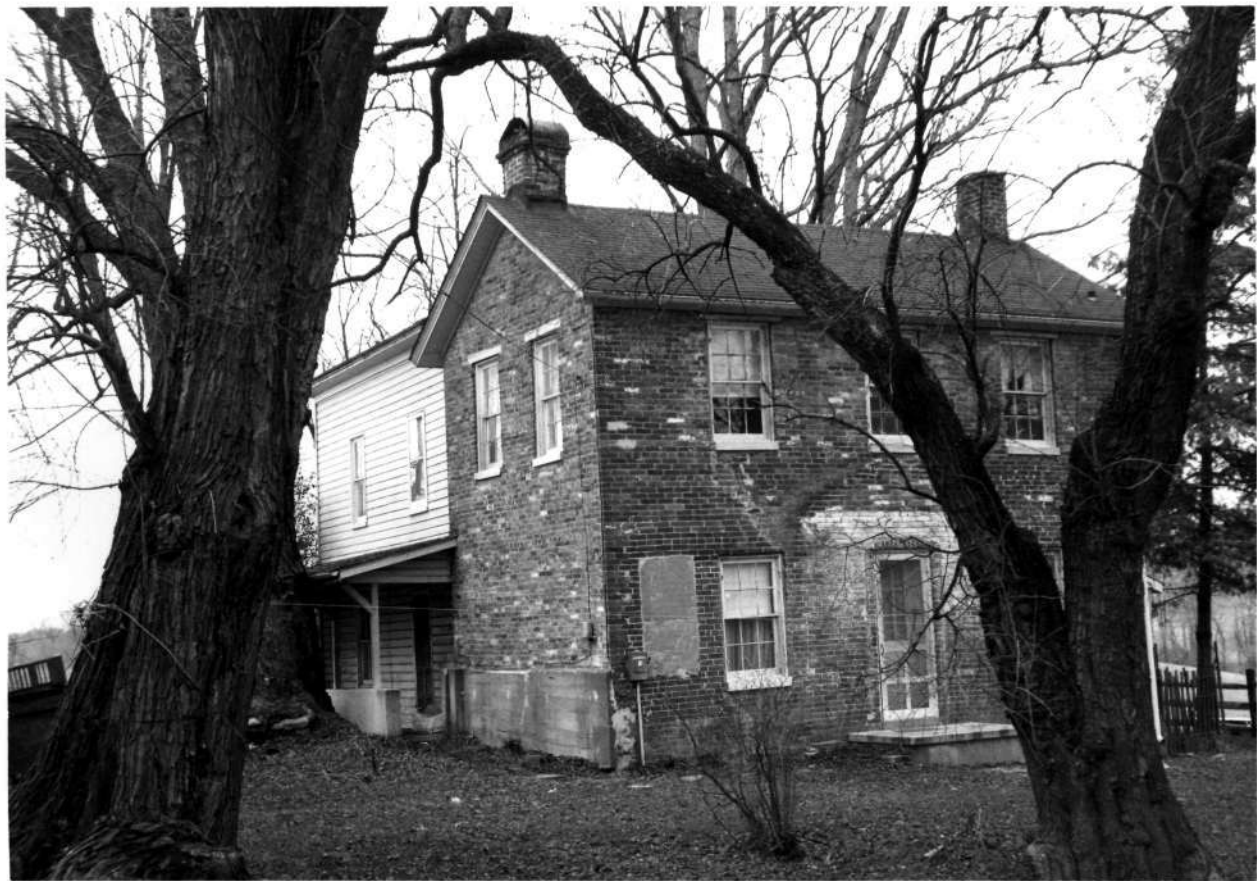
Stanford tenant house
from southeast

Immediately north of the smokehouse is a brick tenant house, two storeys in height with a gable roof. It appears to have been one storey in height originally; window openings appear to have been cut through the original walls after their construction and four closed slits in its north gable resemble those in the nearby stone smokehouse, suggesting that the tenant house was originally an outbuilding, perhaps another smokehouse. Every fifth course in the original walls is a header course. Bricks of the upper storey, and those of the south end, which appear contemporary with the upper storey, are badly deteriorated, while the original bricks are in better condition. The narrowed doorway is centered on the east front and 6/6 windows are in flanking bays. Shutters and a small entrance portico are missing. Extending west is a shed-roofed frame rear wing covered with German siding, its form recalling that of the main house. The approximate dimensions of the original portion are $16\frac{1}{2}$ by 27 feet.

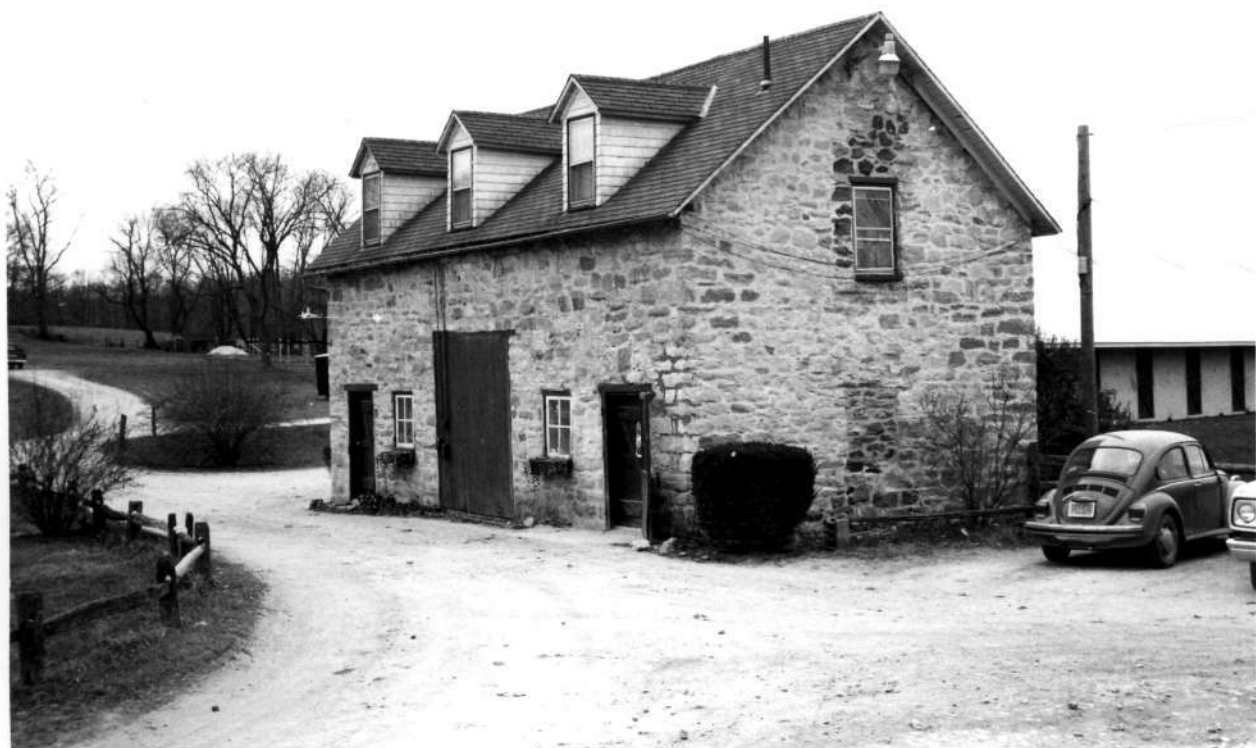
Carriage house from northeast

Some distance southwest of the house is the tackhouse, which was originally a small barn or carriage house. Of stone, one and one-half storeys in height, measuring approximately 20 by 40 feet, it had a large door centered in the east (front) wall, now enclosed with framed walling. A small window and a door of conventional size flank the (former) larger door. Three small windows pierce the west wall, and three dormers light the attic storey. Interior wood elements appear to date from the twentieth century, simple and utilitarian in design.

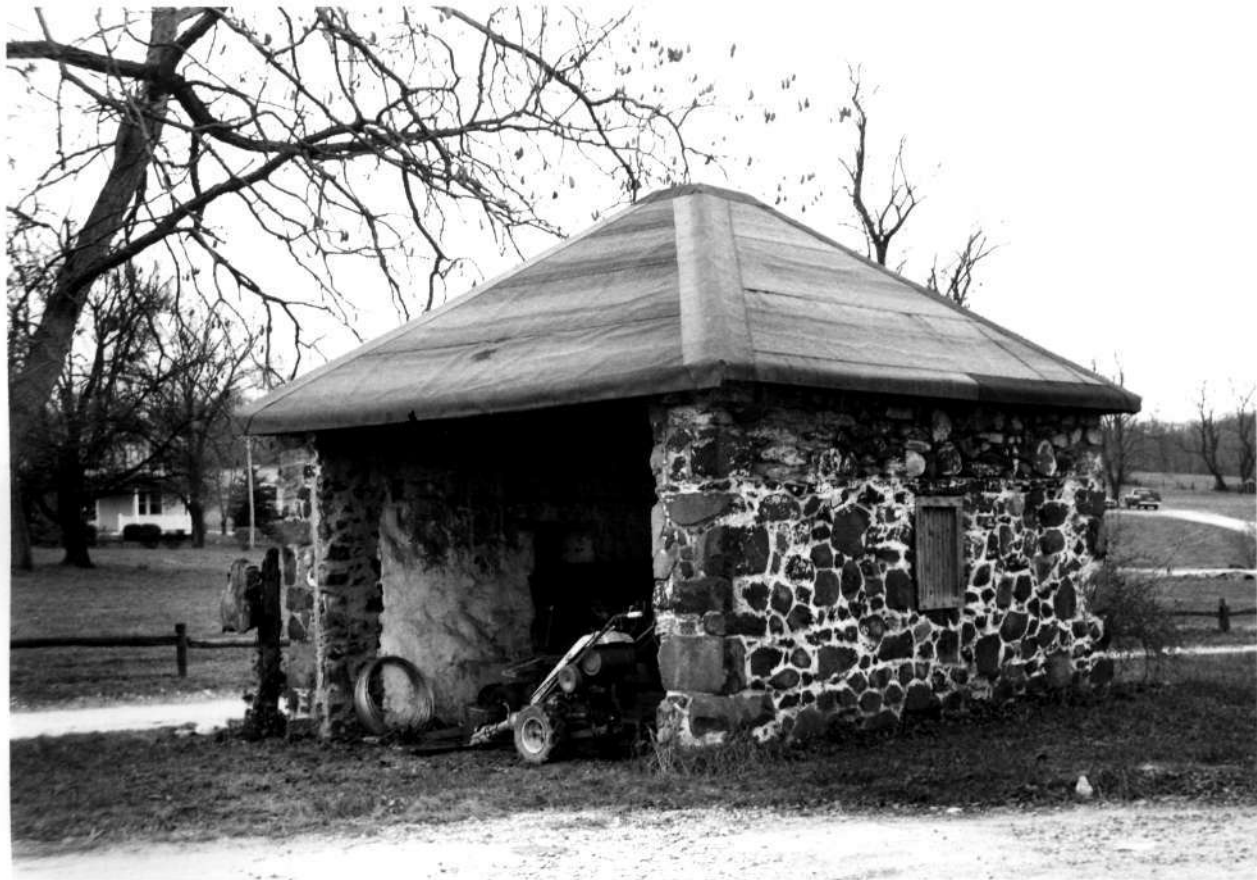
Stanford - outbuilding
from northeast

South of the dairy house is another one storey stone structure, measuring approximately 14 by 15½ feet, with a hipped roof. Now a garage, with its east wall removed for that purpose, it was undoubtedly something else originally, perhaps related to the nearby dairy. Like the dairy, its interior was whitewashed. A small window is through both the north and south walls, and a curious row of rectangular recesses is in interior stonework high in the south wall.

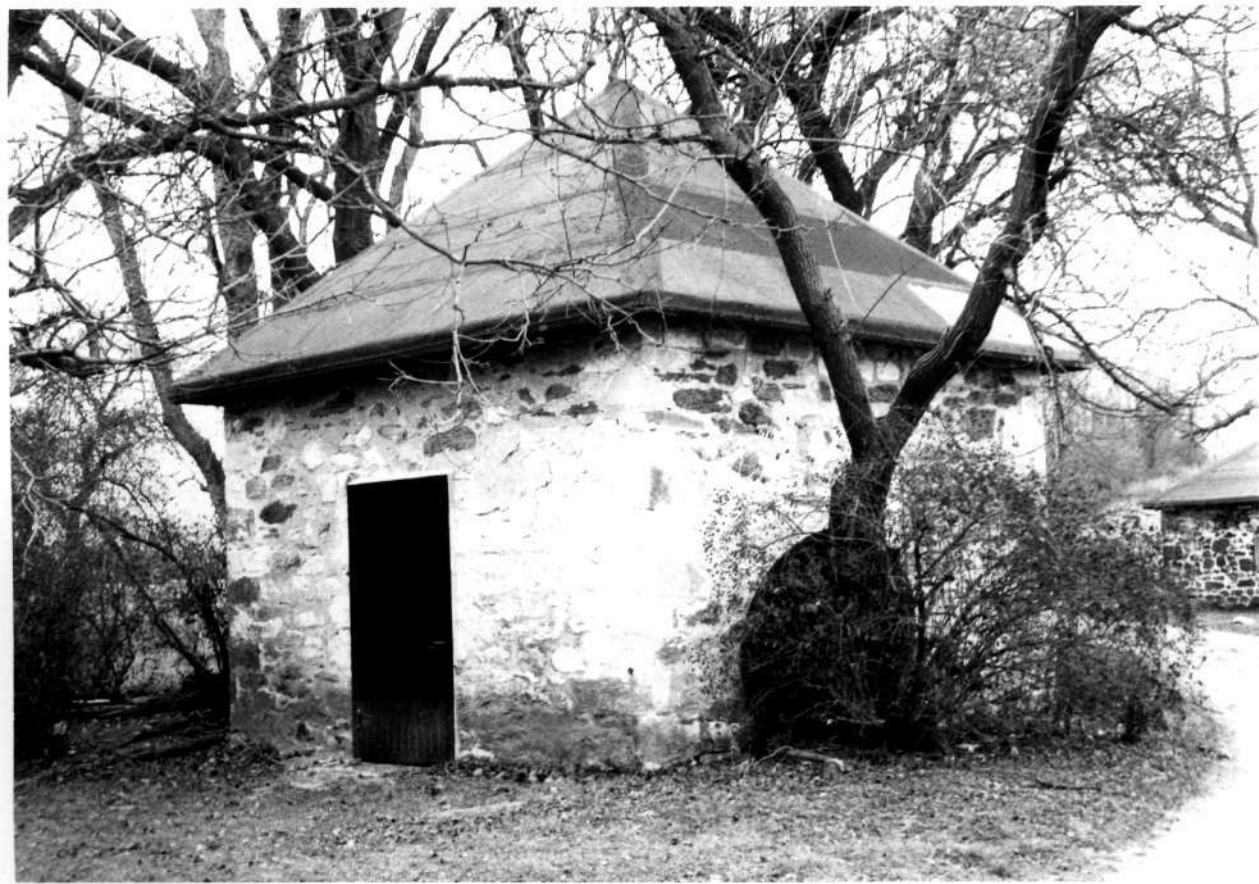
dairy house from northwest

dairy house. It measures approximately 16 feet square. Its entrance is through its north wall. A few log joists remain of a loft or second floor, a few feet below the top of the walls. Window openings in both storeys of its west and south walls have been closed with stone walling, but a louvred window remains in the lower portion of the east wall.

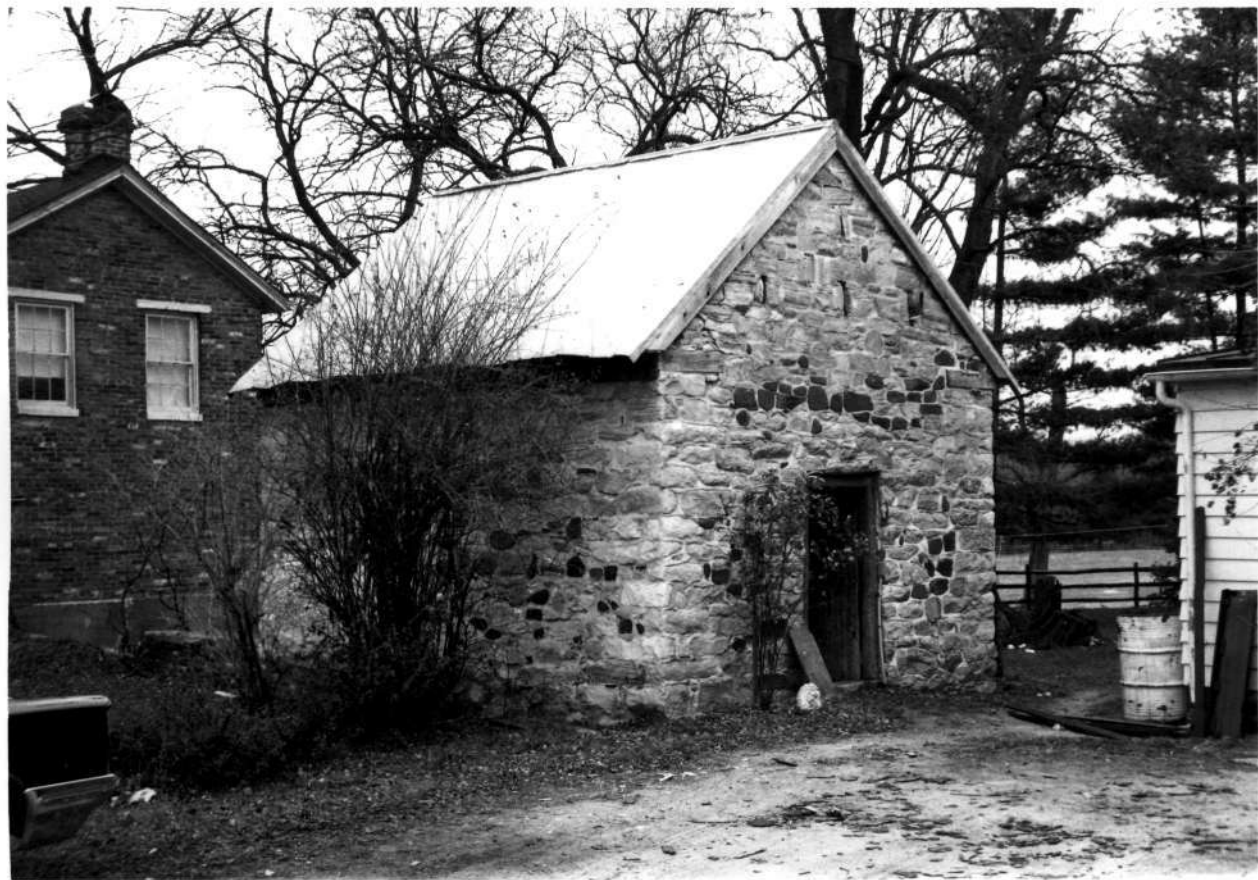
meat house - from southwest

Immediately north of the north wing is a stone smokehouse, one storey in height, with a gable roof, measuring approximately 16 by 18 feet. Its entrance is through a door in its south gable end, and four slit ventilation holes pierce each gable, near the peak.

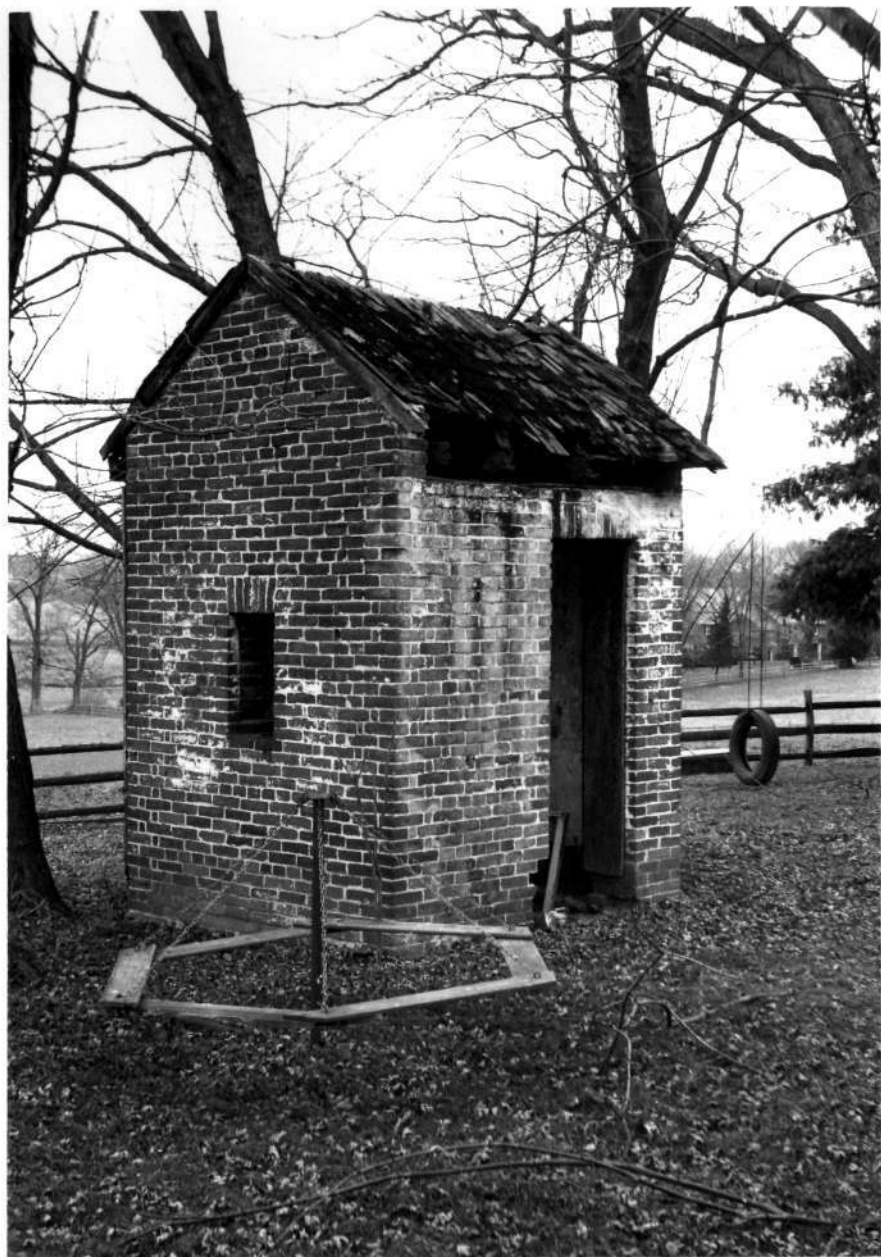
Stanford - privy
from southwest

Six early outbuildings remain; perhaps the rarest of them is the privy, of brick, 7 by 8 feet, with a gabled roof. Of common bond, with closers at the

corners, its door is through the south facade, near the east corner; masonry above is supported by a jack arch. A small window pierces each end wall, with a jack arch above. Wood elements of these openings are missing. Near the ground through the north wall is the long, low cleanout opening. Brickwork above it is falling out. Elements of a moulded cornice remain at the north eave, including a bed moulding and the ghost of a crown moulding. The entire south front cornice is missing where joist ends and roof rafters are rotted away. There was a wood floor, now entirely missing.
